## 10.0 Lowman, Idaho, Disposal Site

### 10.1 Compliance Summary

The Lowman, Idaho, Disposal Site, inspected on July 17, 2007, was in excellent condition. Noxious weed infestations continue to be monitored and sprayed with herbicide; populations of the weeds have been reduced significantly. No cause for a follow-up or contingency inspection was identified.

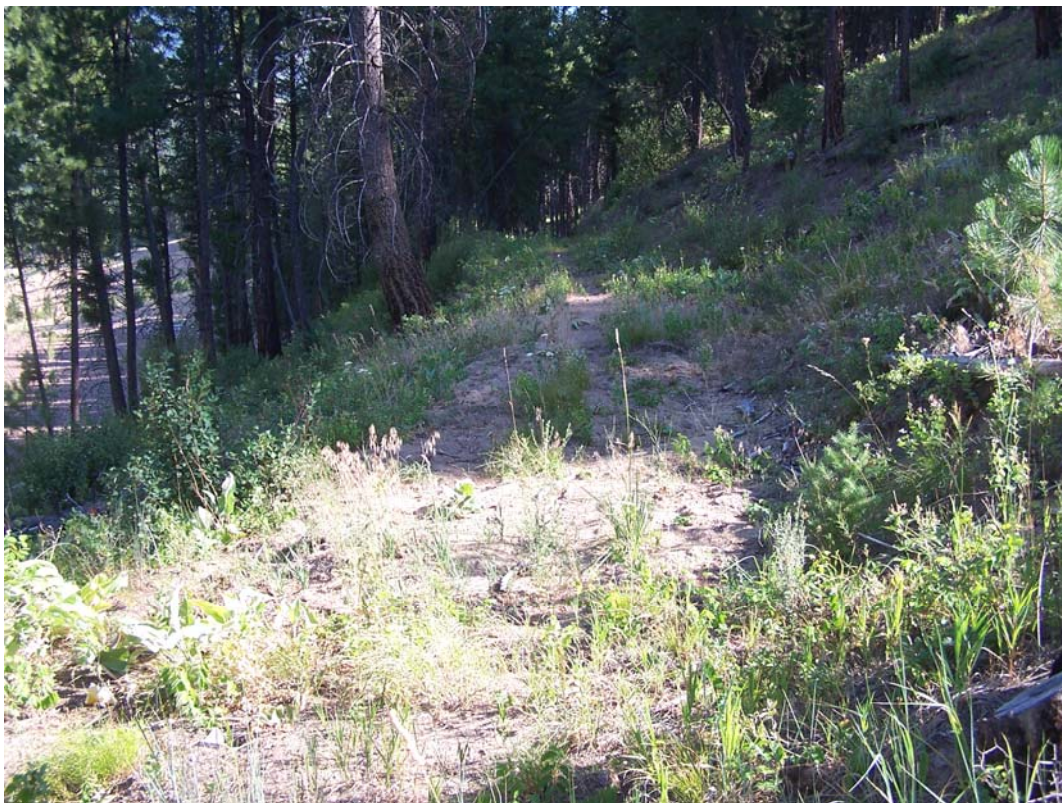
**Monitor Wells**—Groundwater monitoring is no longer required at the site according to the revised LTSP (January 2005). All seven wells were decommissioned in August 2006 in accordance with State of Idaho groundwater protection requirements. The reclaimed well locations were becoming successfully revegetated with seeded and local plant species (PL-1).

*LOW 7/2007. PL-1. Reclaimed location of former monitor well LOW-01-029.*

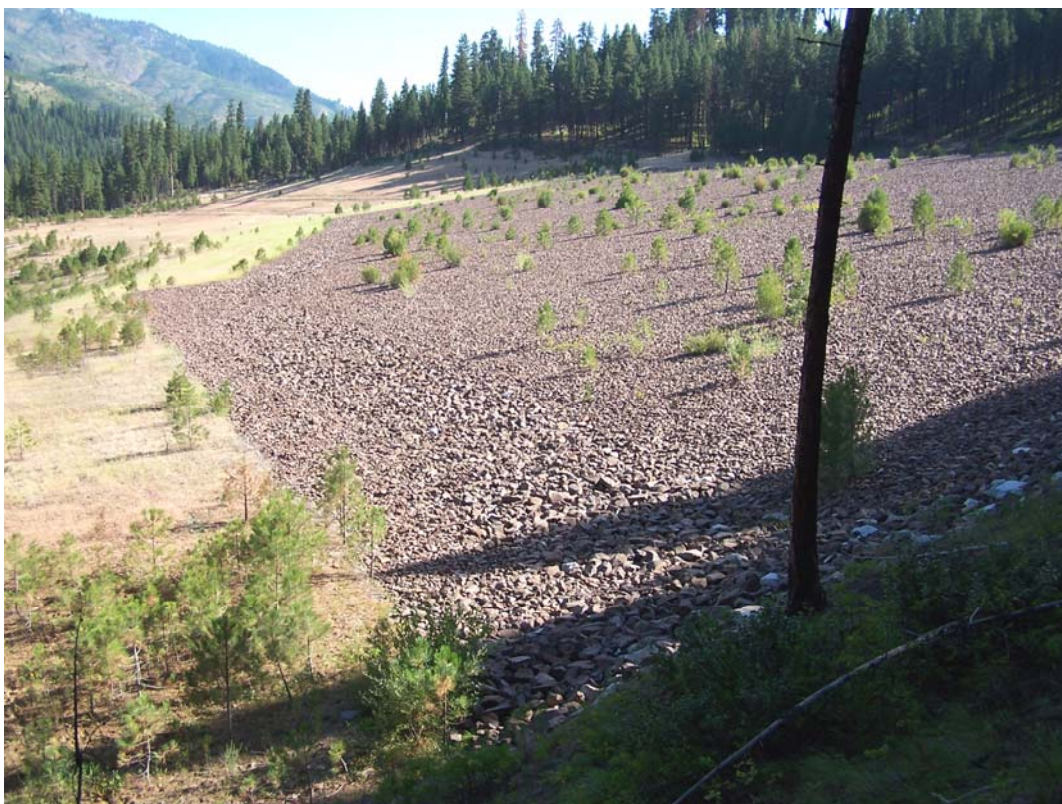
**Top and Side Slope of the Disposal Cell**—The 8-acre disposal cell was completed in 1991. Basalt riprap armors the top and west-facing side slope of the disposal cell. An apron of larger riprap surrounds the disposal cell on all sides. The riprap was in excellent condition, and no evidence of instability, such as subsidence, slumping, or cracking was observed on any of the cell surfaces (PL-2 and PL-3).

Vegetation encroachment by species including ponderosa pine continues on the top and side slopes of the disposal cell (PL-2, PL-3, and PL-4). Encroachment is a natural process operating at this location and will be allowed to continue in accordance with the LTSP. Although DOE is no longer required to remove pine trees as they mature, the revised LTSP states that DOE will repair any damage that may occur to the riprap cover and underlying cover layers caused by blowdown or other processes to maintain protection from erosion and possible consequent dispersion of cell contents. The largest ponderosa pine trees on the cover are now approximately 7 feet tall.

*LOW 7/2007. PL-2. The west portion of the disposal cell.*

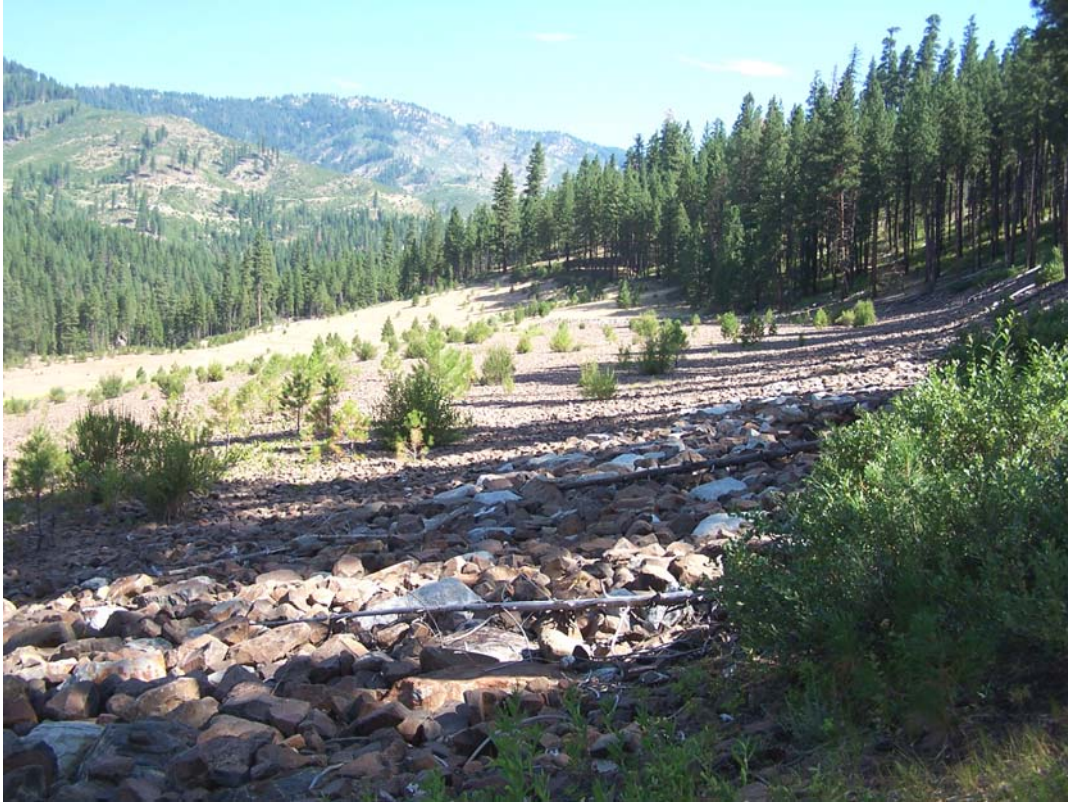
*LOW 7/2007. PL-3. The apron and cover along the east side of the disposal cell.*

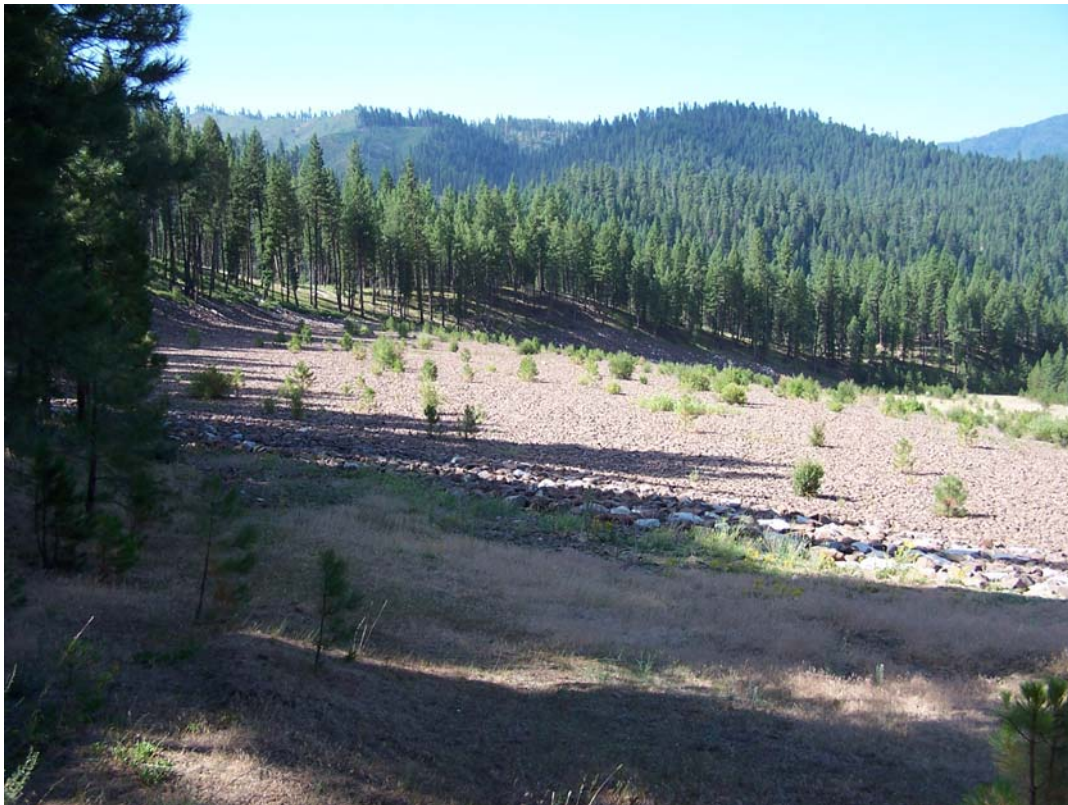
*LOW 7/2007. PL-4. The east portion of the disposal cell.*
